Upton Tornado Study by Tom Dodd

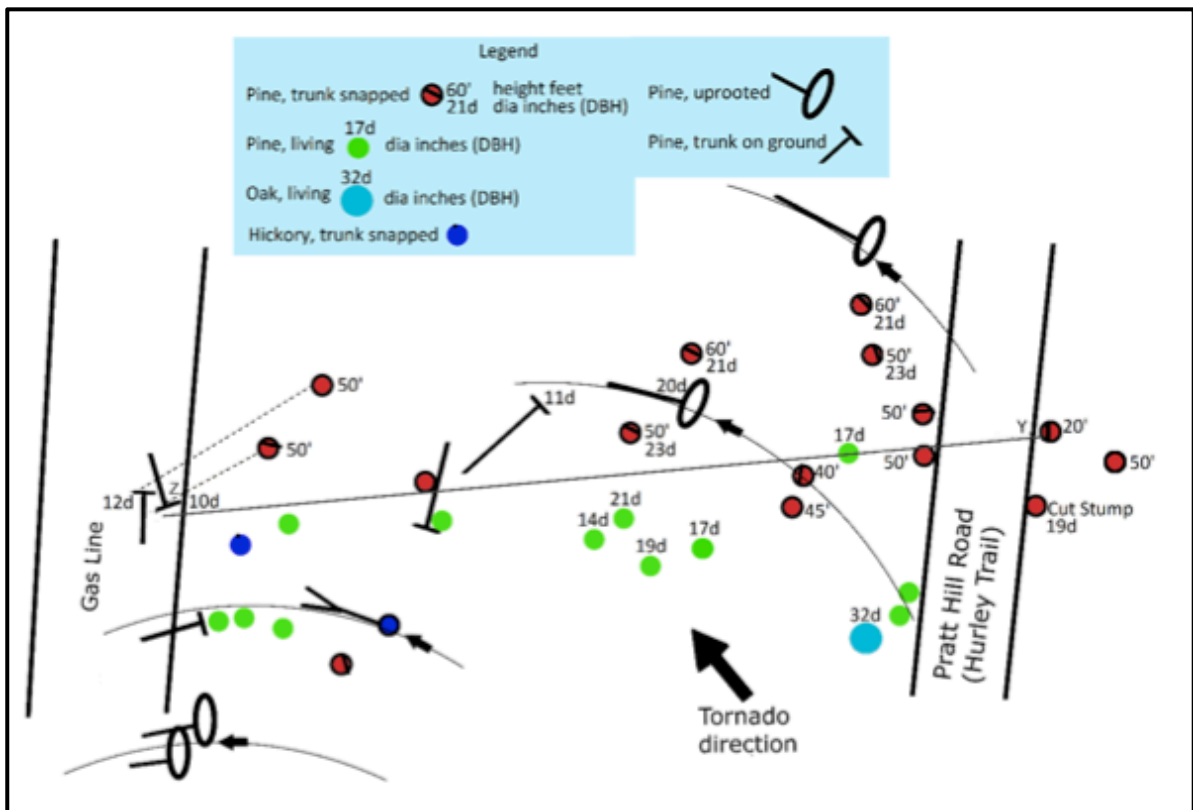
The map below shows the transect line through the tornado path and provides some perspective as to the damage that was inflicted. There are areas north of the gas line that sustained much heavier damage than this section. However, this section was more accessible and visible from Pratt Hill Road and probably easier to maneuver among the fallen trees.

Damage along transect line

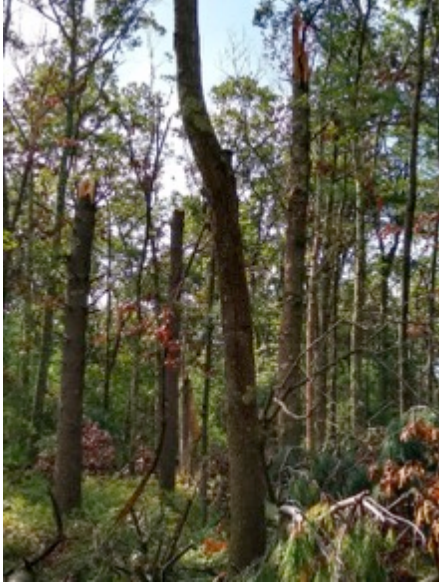
Spotty damage near top of Pratt Hill

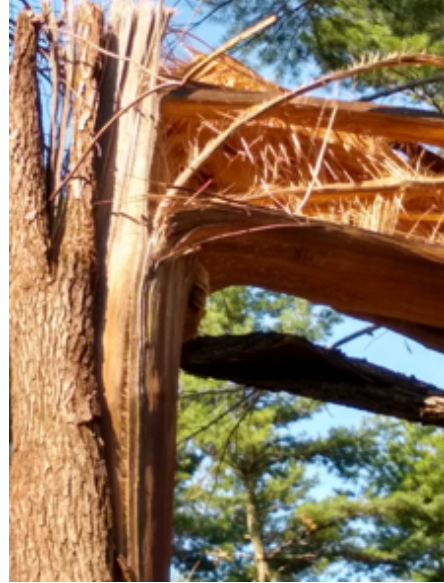
Hickory Tree damage – wrenched apart

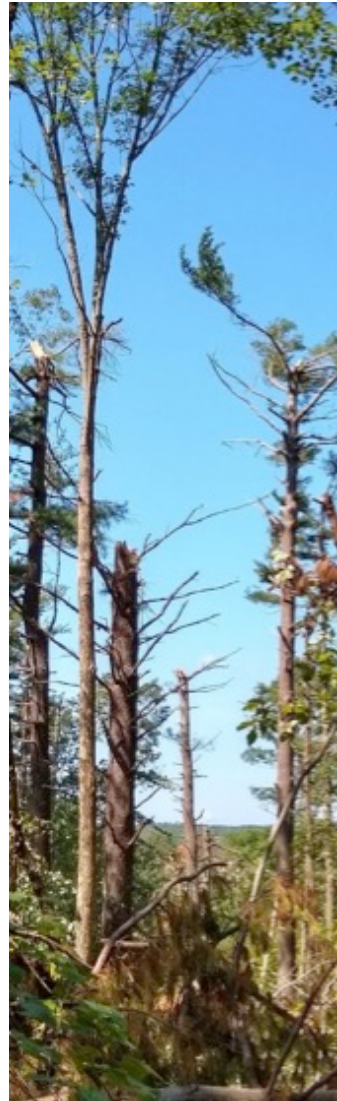
There were many White Pine trees that had been snapped at about the 50-foot height along with others that had been uprooted. A large oak seemed to be untouched, all of its leaves and branches intact while possibly affording protection to a few pines from the strongest winds. One hickory was killed, but did not just snap like the pines, it was wrenched apart, with strands of interior wood fibers peeling apart in an ordered appearance. The understory hickories and maples showed damage from the upper tree trunks that had fallen on them, with the young tree tops bent to the ground in an arched manner. The forest floor plants showed no damage except from fallen trunks and branches that now covered them.

Pine trees snapped off at about 50'. Dying branches along ground.

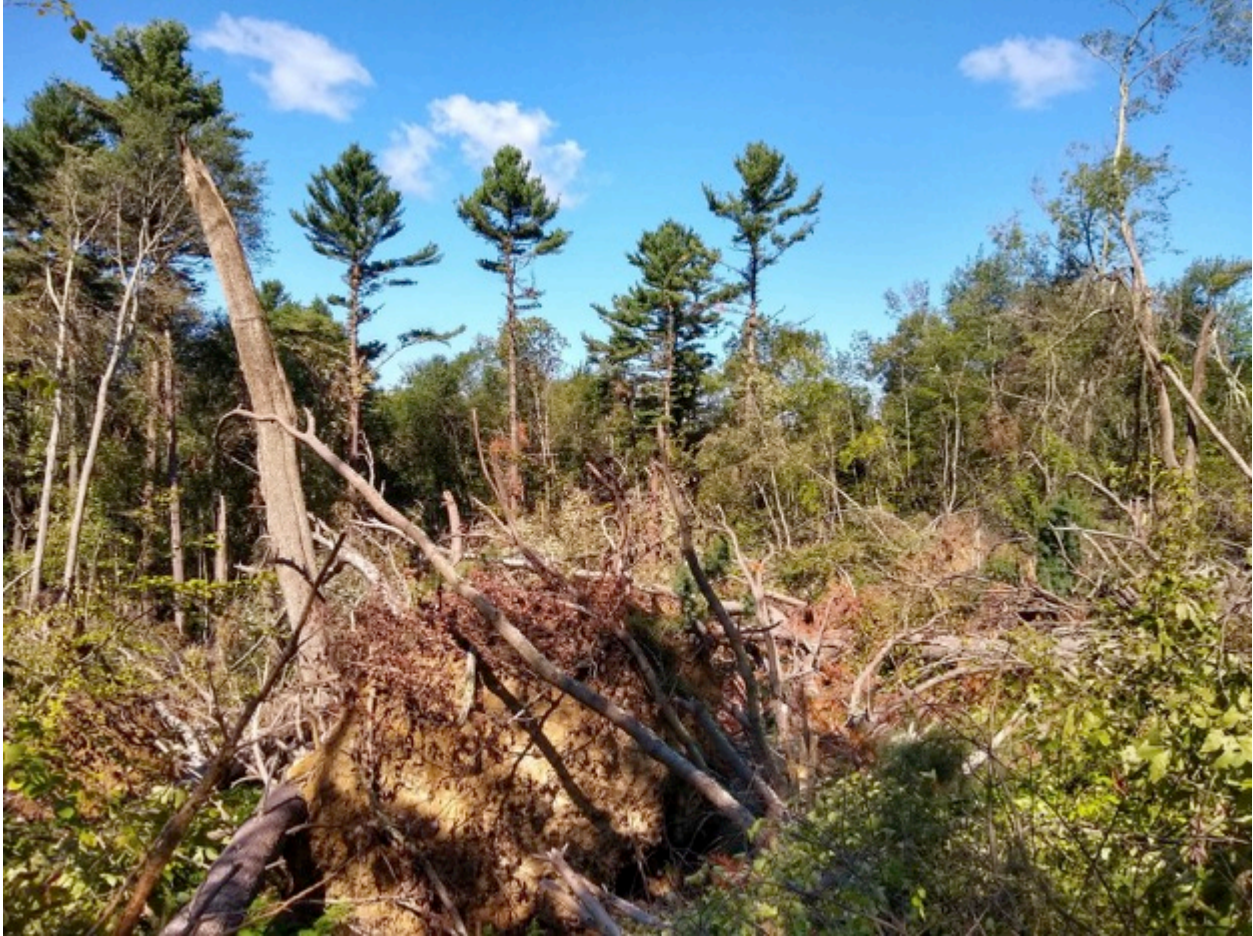
Most damaged section just north of gas line – Many pine trees have been uprooted – all trees down
